**CONNECTICUT RIVER BASIN
WESTFIELD, MASSACHUSETTS**

**POWDERMILL BROOK
DETENTION DAM
MA 00605**

**PHASE I INSPECTION REPORT
NATIONAL DAM INSPECTION PROGRAM**

AUGUST 1978

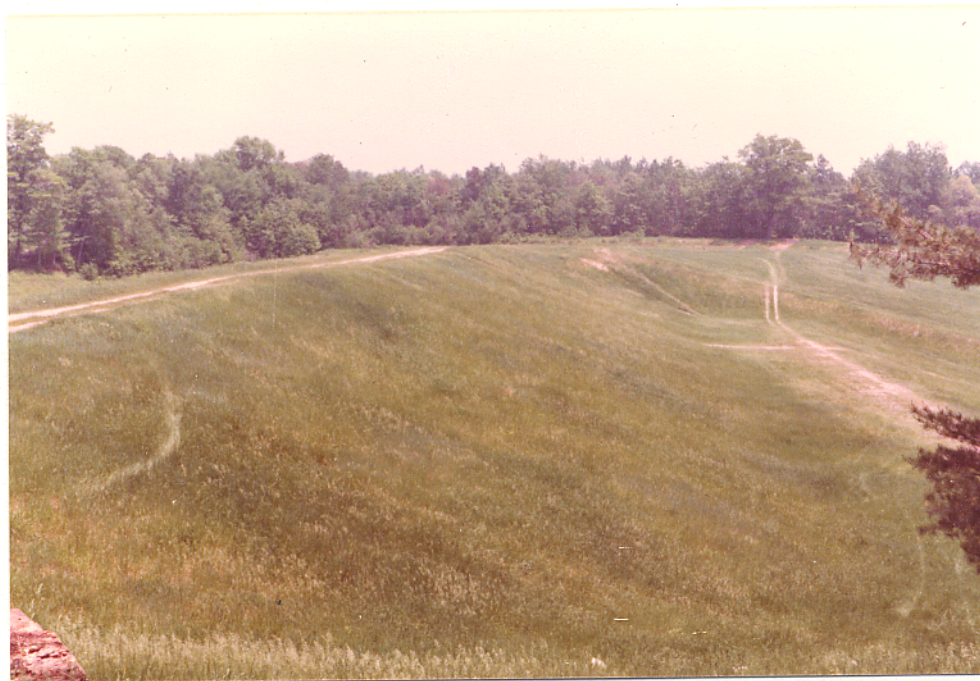
The crest of the dam has no pavement. Vehicular traffic has caused erosion on the crest which can be seen in Photos 1 and 2*. The erosion is very bad at the left end of the crest where it contacts the spillway slope. This area is shown in Photo 2.

PHOTO NO. 1 - Downstream slope from right abutment

(1) Repair surface erosion channels at abutment/embankment contact and on the upstream and downstream faces.

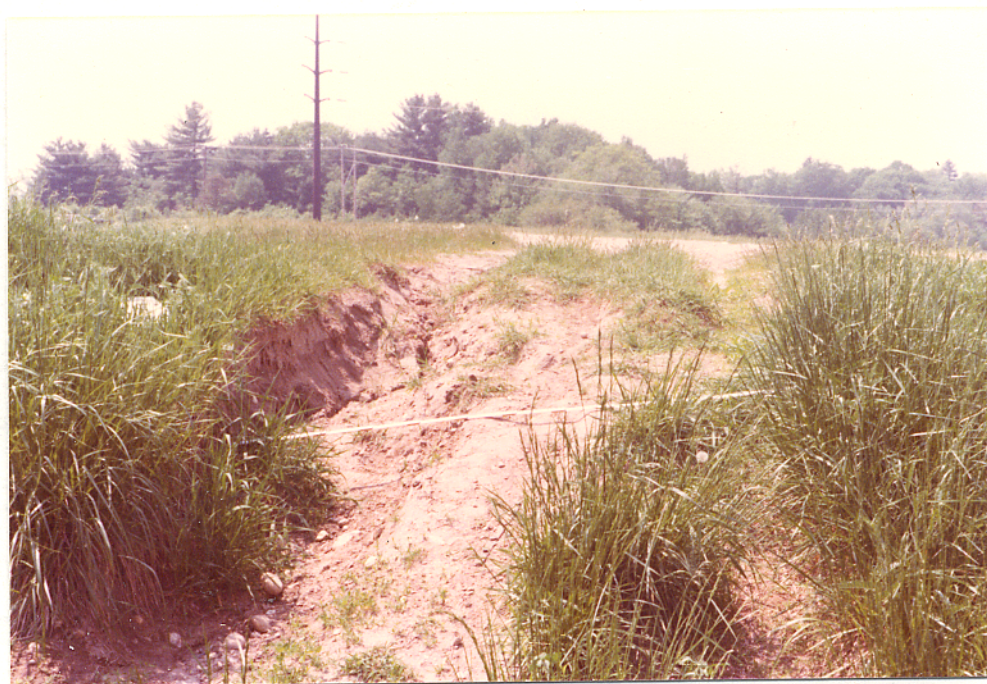
PHOTO NO. 2 - Erosion on end slope from dam crest to spillway floor

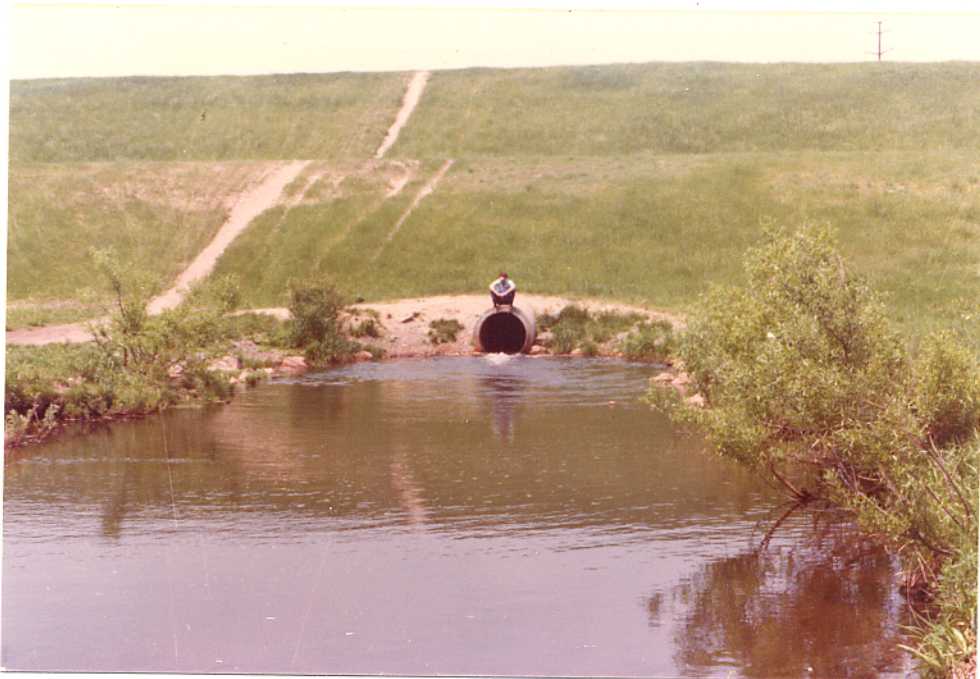
Motor bikes have caused erosion on the dam face from the toe to the crest as can be seen in Photo3.

PHOTO NO. 3 - Downstream slope showing erosion due to trespassing on slope

channels on the embankment caused by vehicular traffic should be repaired. Barriers should be installed to prevent further intrusion by motorized vehicles.

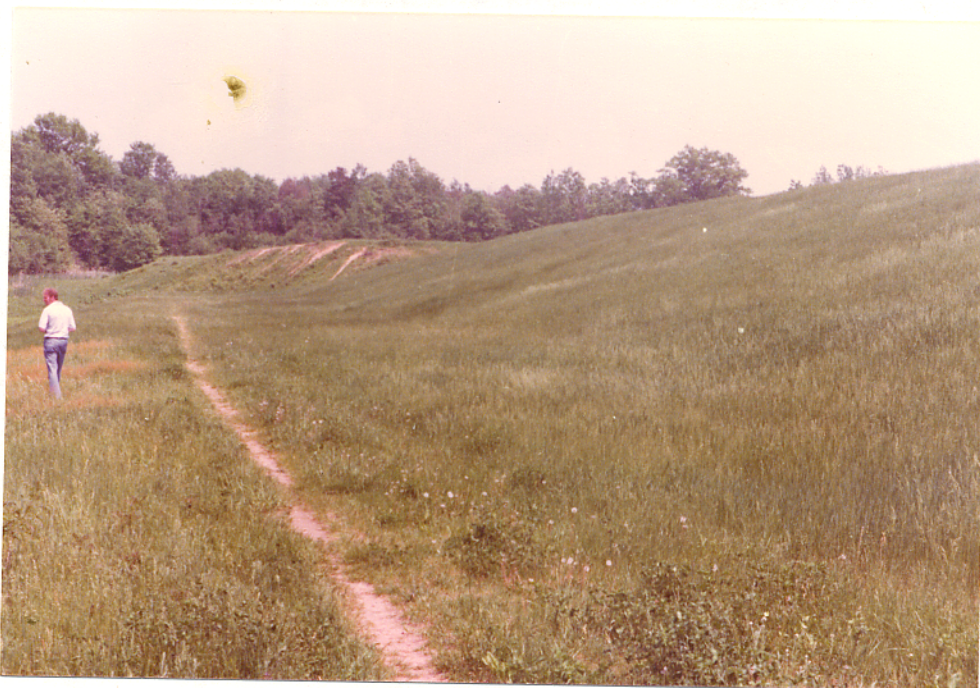
The emergency spillway is a vegetated spillway with soil slope training walls. In general the spillway is in good condition. There has been local erosion as a result of motor bike traffic. The area of particular concern is the slope adjacent to the left abutment as shown in Photo 4.

PHOTO NO. 4 - Upstream slope showing erosion of left abutment area.

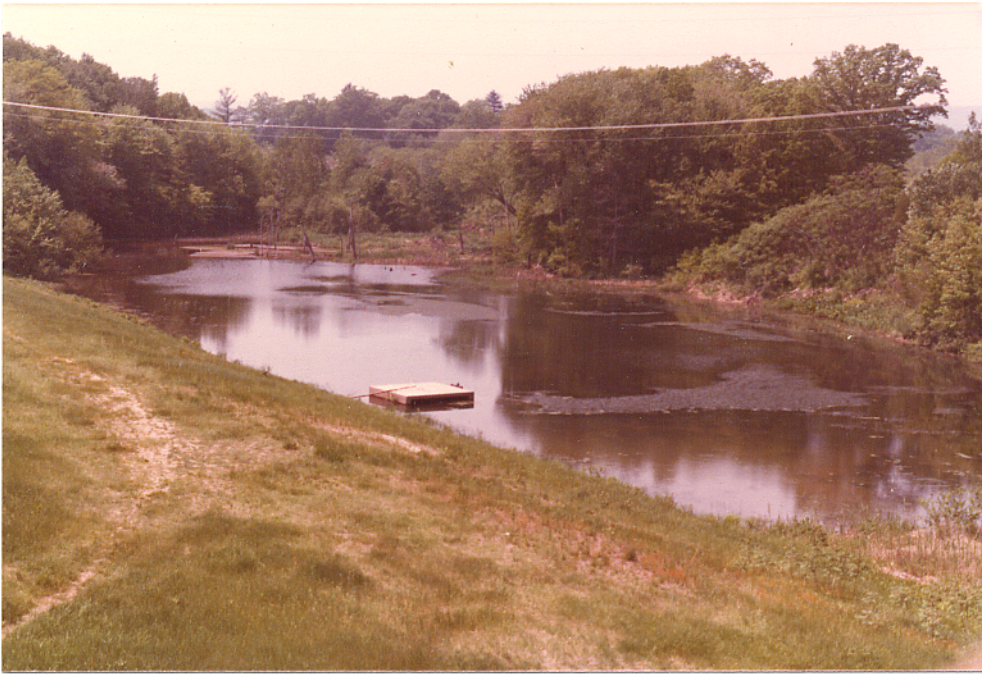
PHOTO NO. 5 - General view of normal impoundment and intake structure

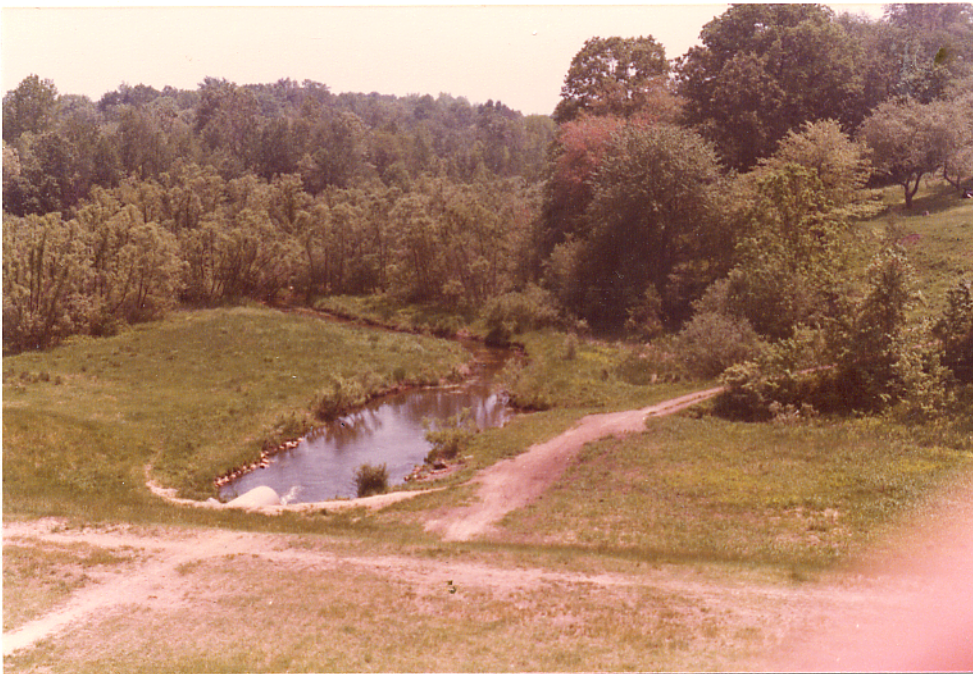
The downstream channel flows for about 300' in open area then becomes wooded. There is some grass growing in the channel bottom and a small amount of wooded debris can be found downstream. The channel is, however, flowing freely. This can be seen in Photos 6 and 7.

PHOTO NO. 6 - General view of outlet channel

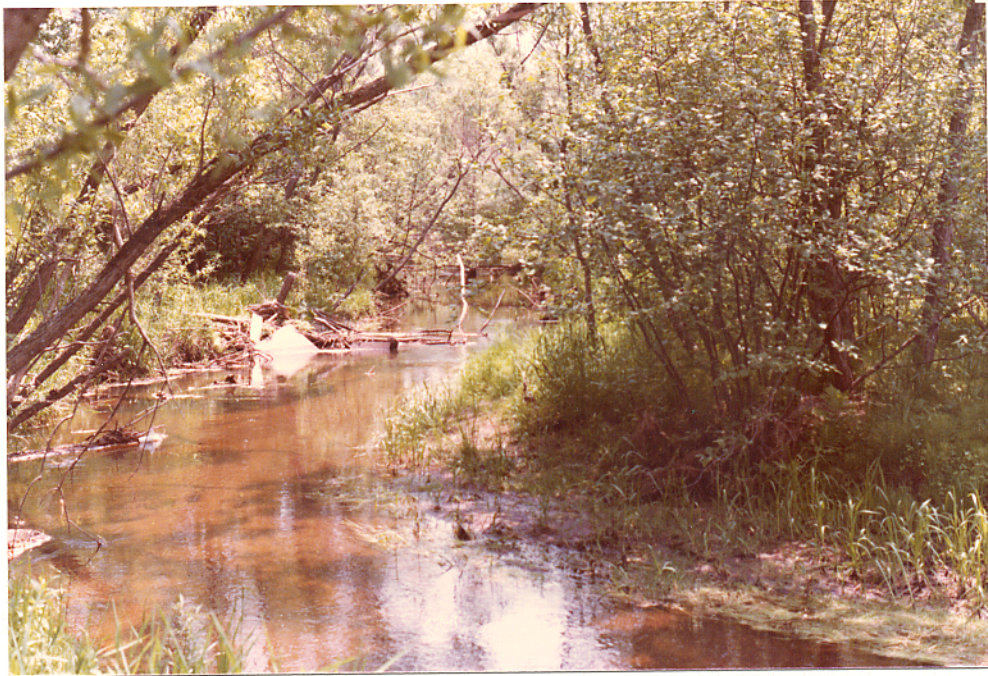
PHOTO NO. 7 - Close up of outlet channel in wooded area
below dam
